CHAPTER 9

HOUSING IN HAGLEY

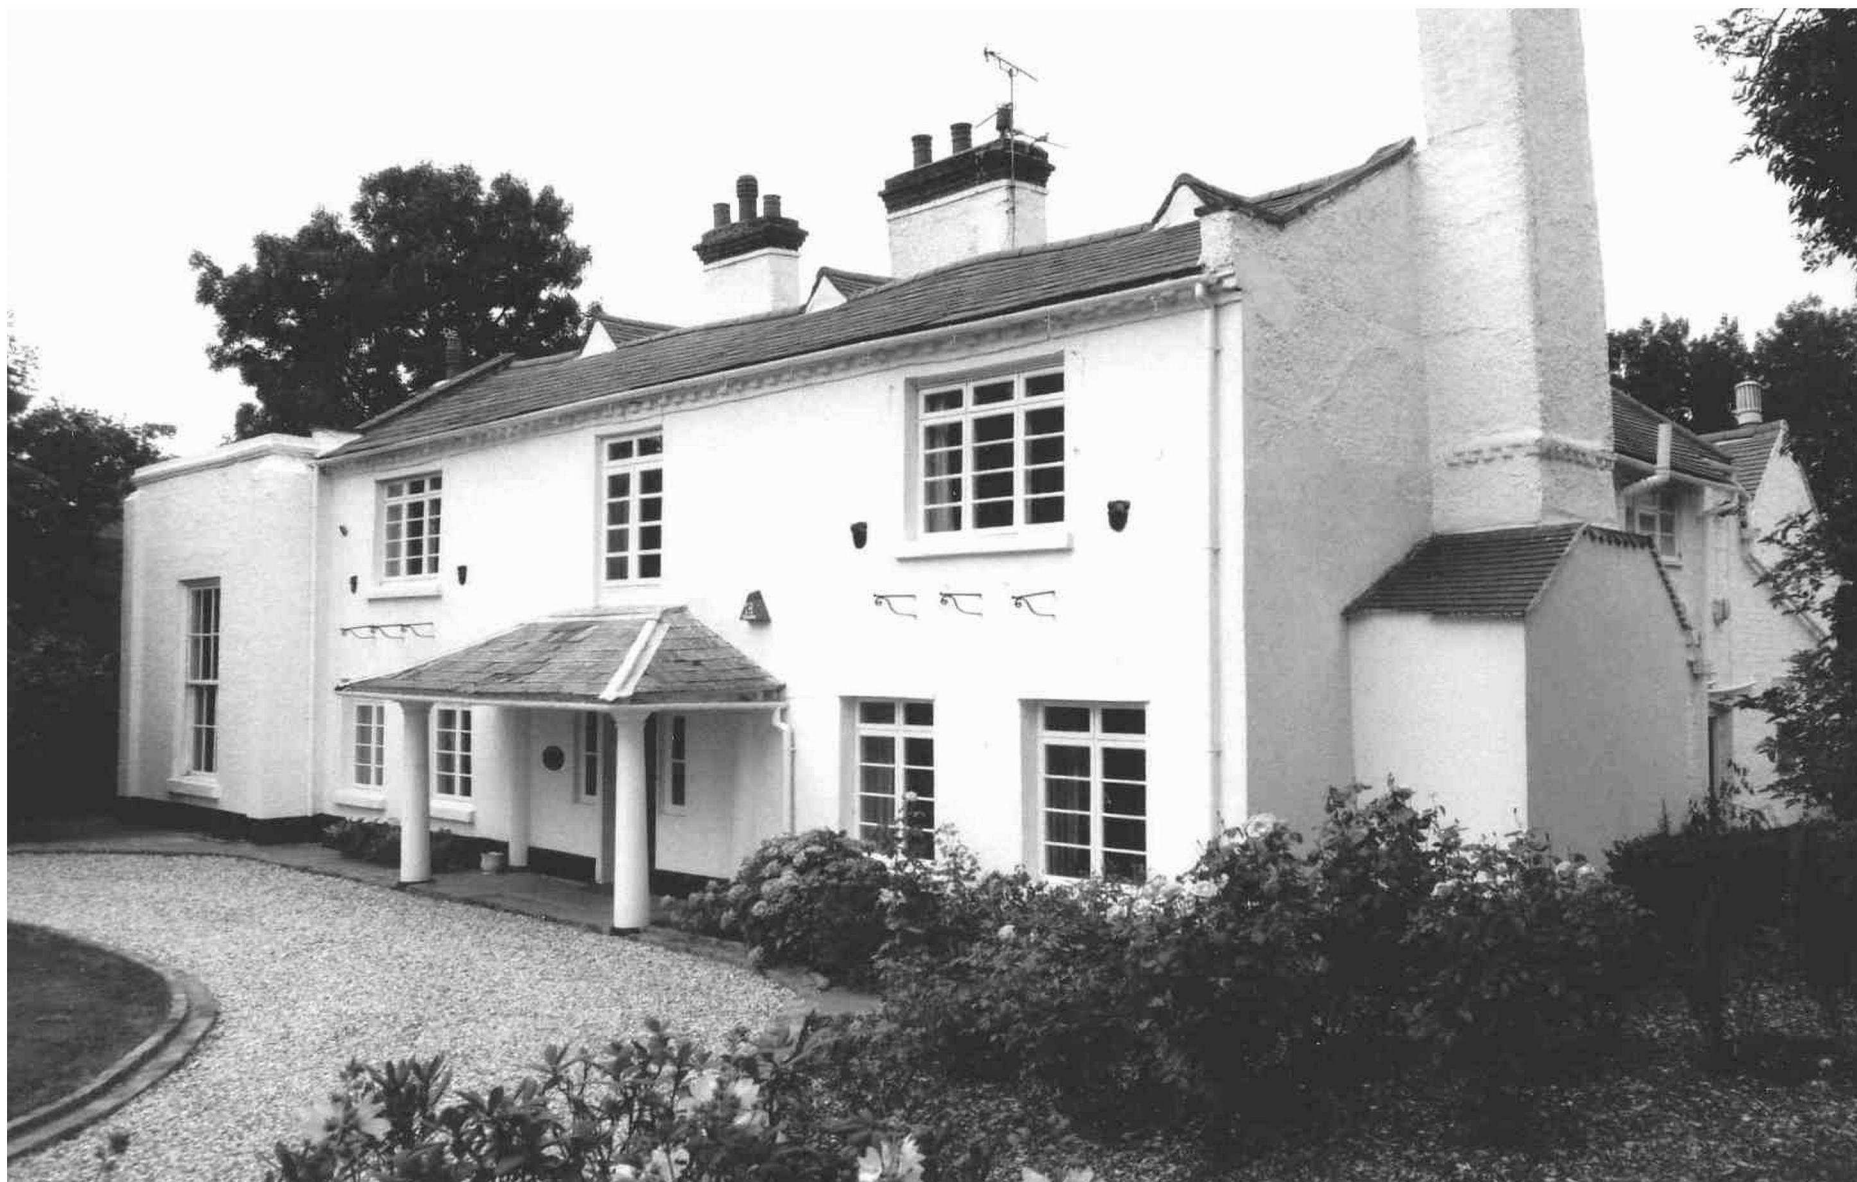
One of the houses in Hagley which was recently surveyed by the author and others. It is considered to have been started in about 1600.

The second⁸¹ opportunity to occur was in Hall Lane. The building presents a Victorian façade to the road with some later modifications. The owners were seeking any historical information that would enable them to date their home and approached the writer. There was little information readily available and the earliest record was the 1838 tithe map and schedule which indicated a building divided into two

The building had been developed over seven phases, from the early 17th century to c1935. Sandstone footings in much of the front half of the building suggested the first two phases of a timber-framed building. Examples of wattle and daub were found in more than one room and the trusses above the older part of the house showed that they had been partially modified to accept a new roofline in the 19th century.

The three chimneystacks showed evidence of changes and extensions and the house was extended backwards to provide more than double the floor area.
